# IN-WELL REMEDIATION SERVICES

# ART In-Well Integrated Case Study

# ART IN-WELL INTEGRATED TECHNOLOGIES CASE STUDY

*Rapid Redevelopment: Restoring a Heavily Impacted Site for Immediate Community Use*

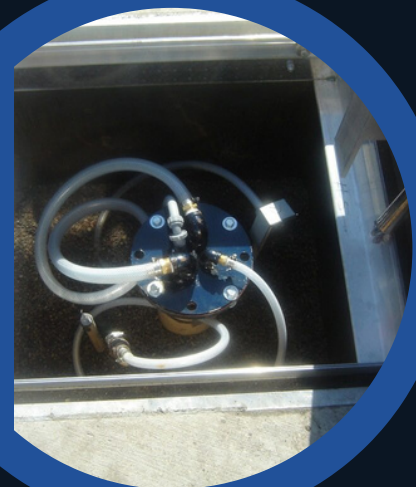
Photo: External view of ART In-Well Integrated Well
